Re: Notice of Violation  
Compliance Evaluation Inspection  
MND 980 996 805

# Photographs for Enviro-Chem CEI 7/29/2014

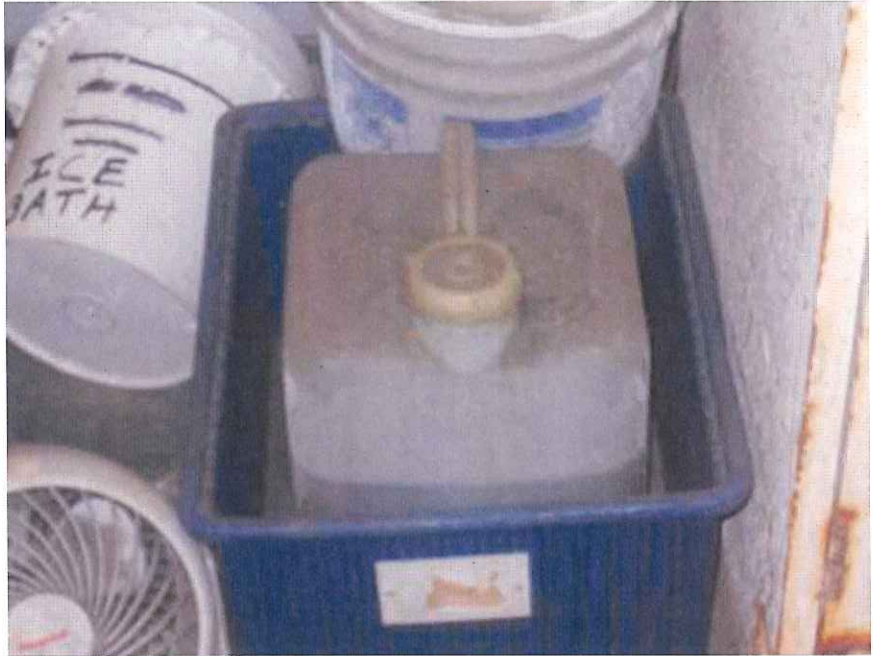
**Disk Number** 1  
**Photo Number** 2  
**Photo Filename** DSCN0674.JPG  
**Date/Time** 7/29/2014  
10:40:00 AM  
**Photographer** Jamie Paulin

Laboratory. Waste acid was being collected after use and was stored in an SAA, located in the laboratory.

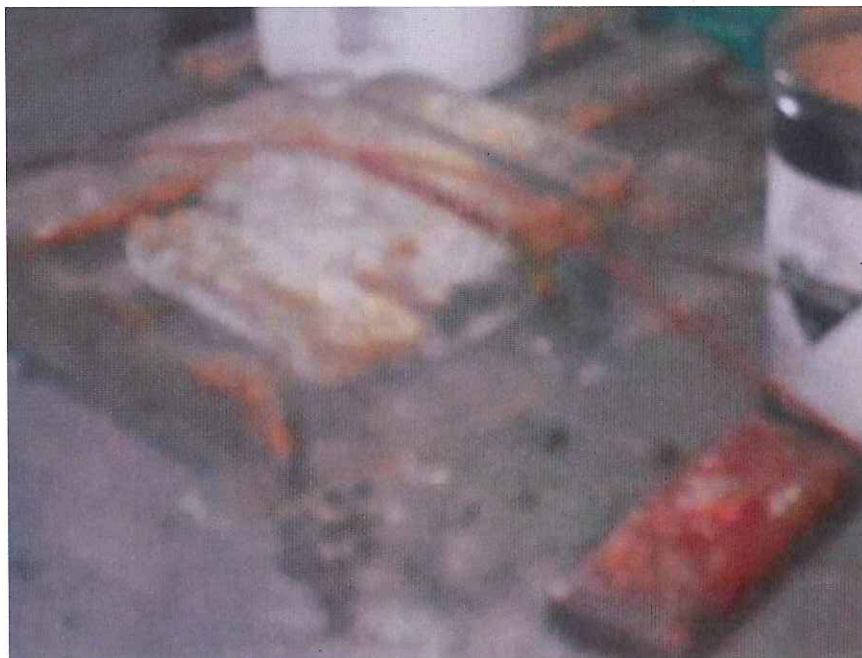
Main processing area. Metal bars were being melted in the furnace for precious metals recovery.

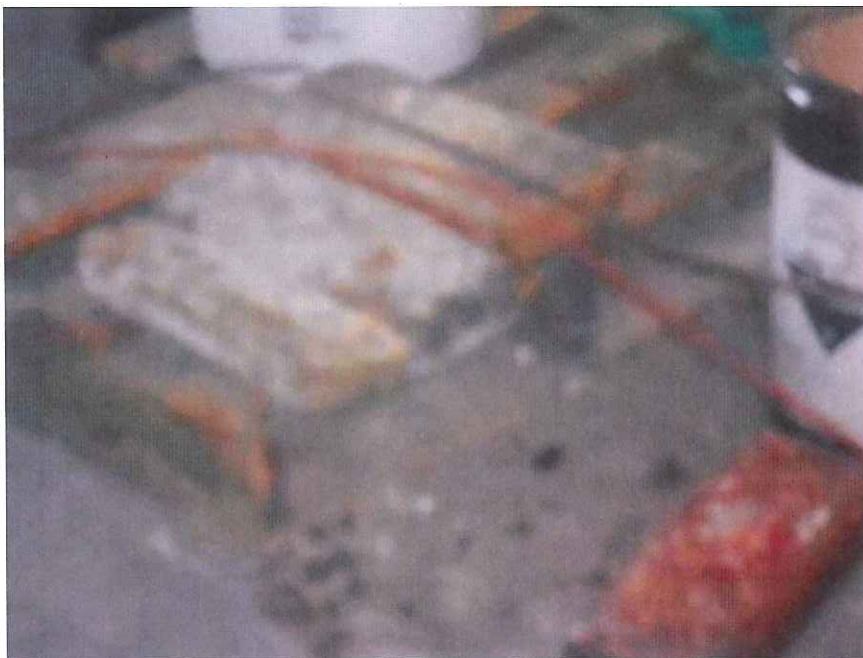
Main processing area. Metal bars were being melted in the furnace for precious metals recovery.

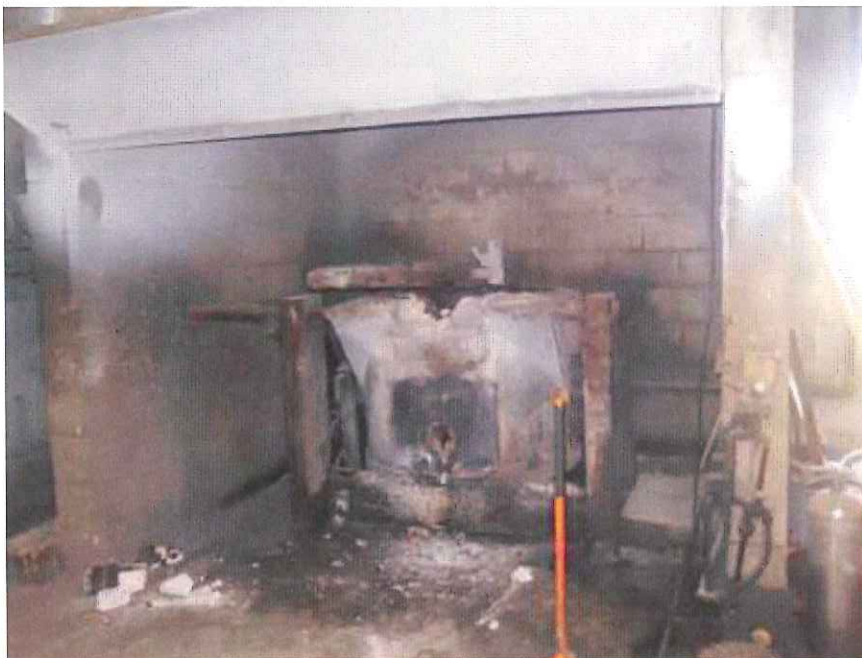
**Disk Number** 1  
**Photo Number** 6  
**Photo Filename** DSCN0678.JPG  
**Date/Time** 7/29/2014  
10:45:00 AM  
**Photographer** Jamie Paulin

Main processing area. One of the melting furnaces that is used for melting the metal was located here.

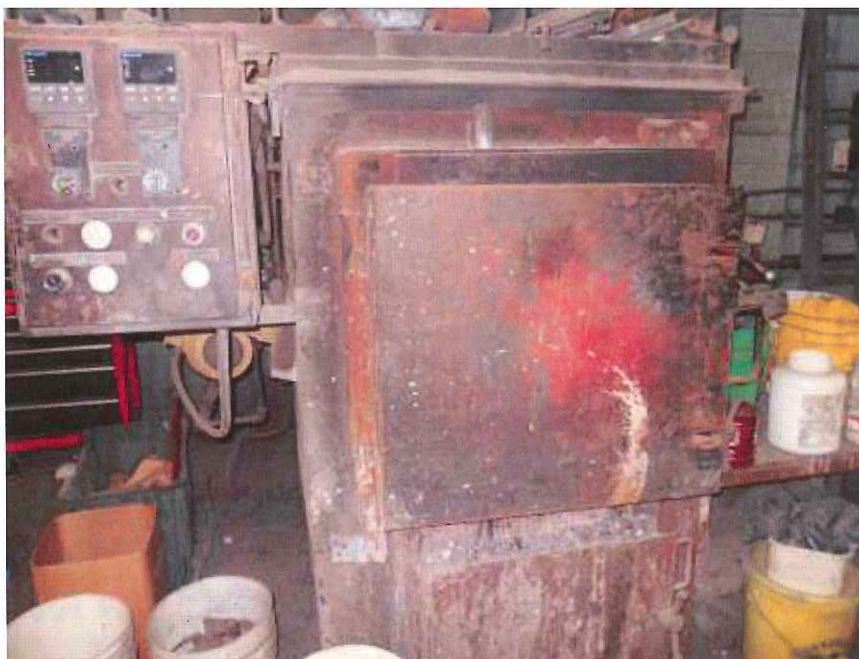
Incinerator located in the main processing area.

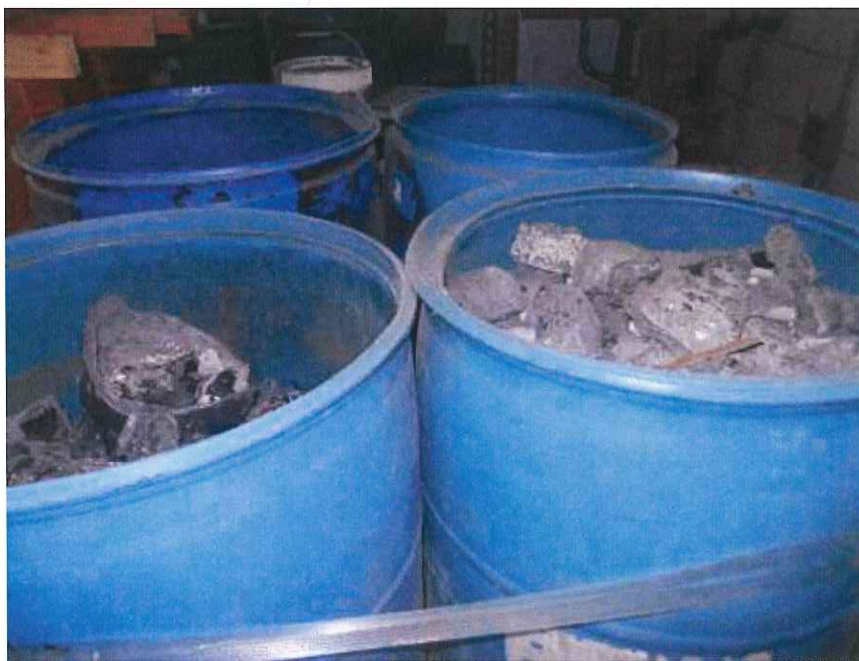
**Disk Number** 1  
**Photo Number** 8  
**Photo Filename** DSCN0680.JPG  
**Date/Time** 7/29/2014  
10:48:00 AM  
**Photographer** Jamie Paulin

Residual ash that is collected from the furnaces is sent off-site to be refined.

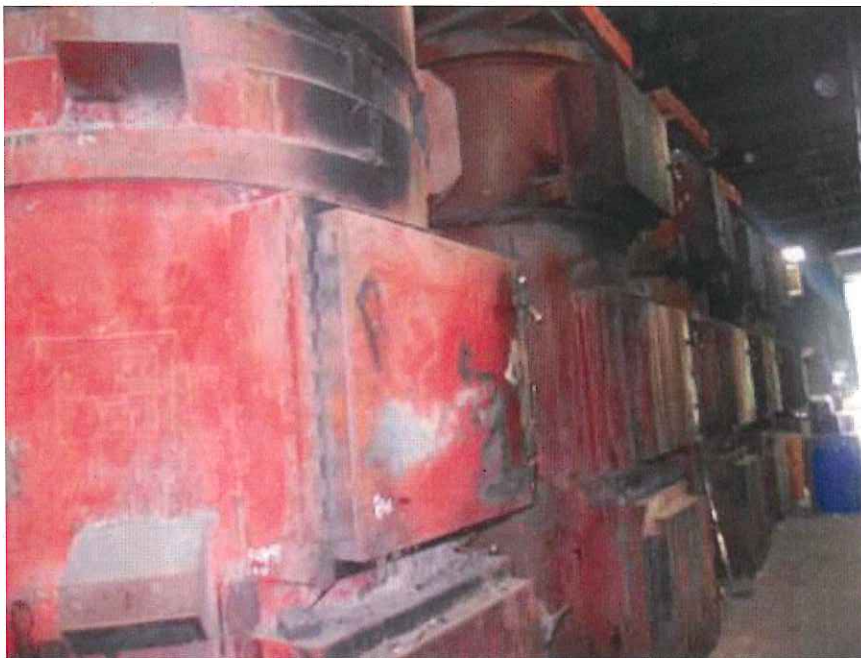
Row of incinerators, incinerator piping and after burners were located in the main processing area.

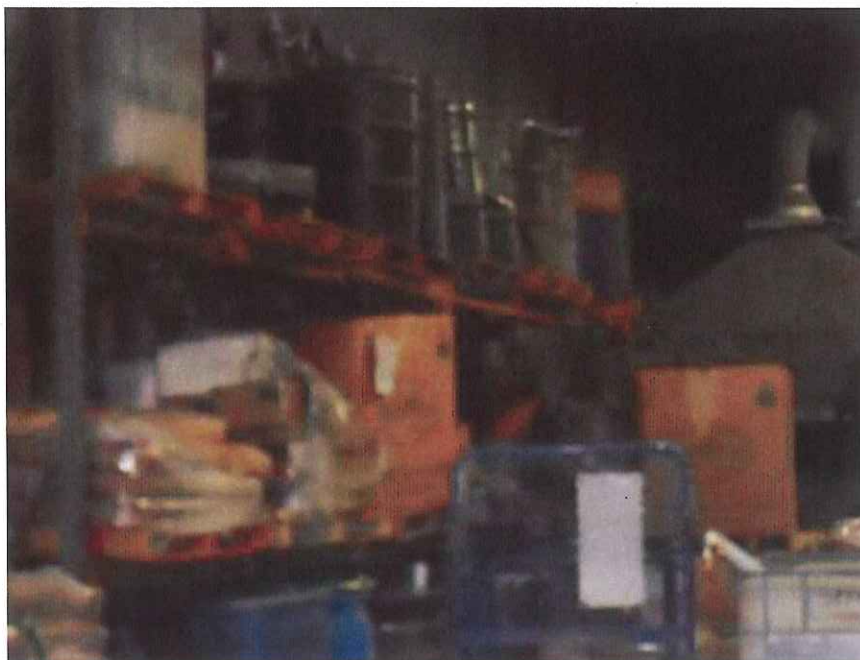
**Disk Number** 1  
**Photo Number** 10  
**Photo Filename** DSCN0682.JPG  
**Date/Time** 7/29/2014  
10:55:00 AM  
**Photographer** Jamie Paulin

Raw materials were being stored on shelves located in the main processing area.

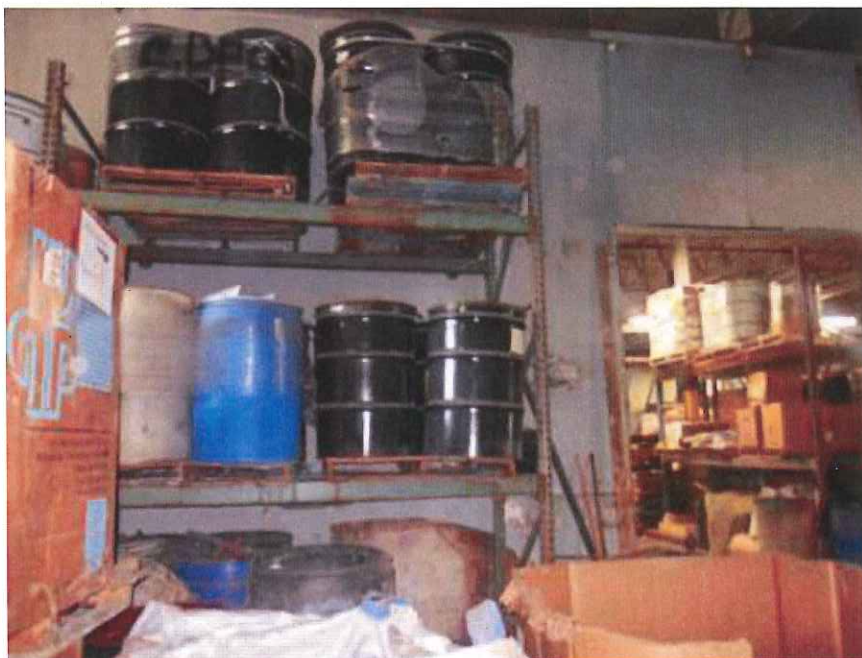
Shelving unit, main processing area. The 55-gallon containers were storing material that was waiting to be processed.

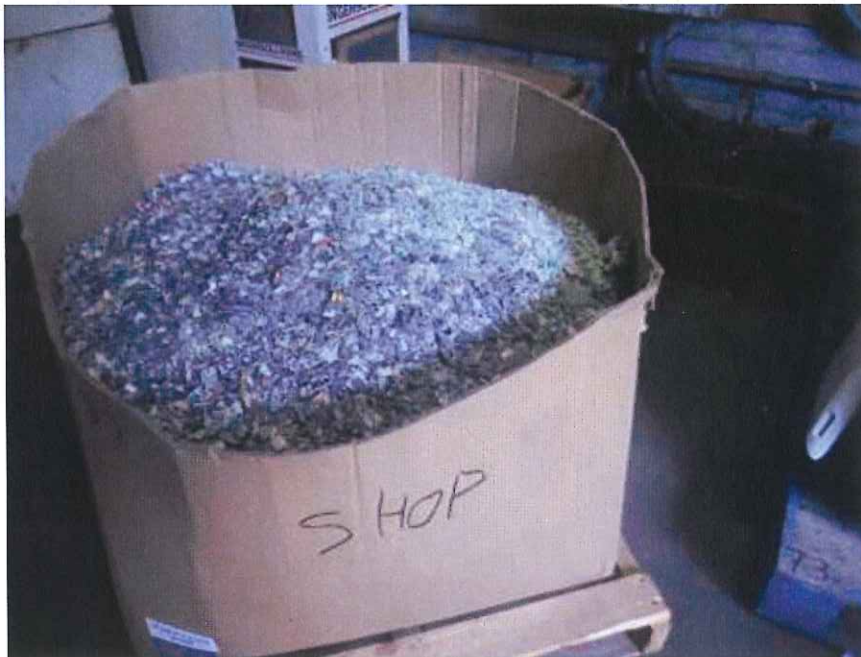
**Disk Number** 1  
**Photo Number** 12  
**Photo Filename** DSCN0684.JPG  
**Date/Time** 7/29/2014  
10:58:00 AM  
**Photographer** Jamie Paulin

Sample of plastic after shredding.

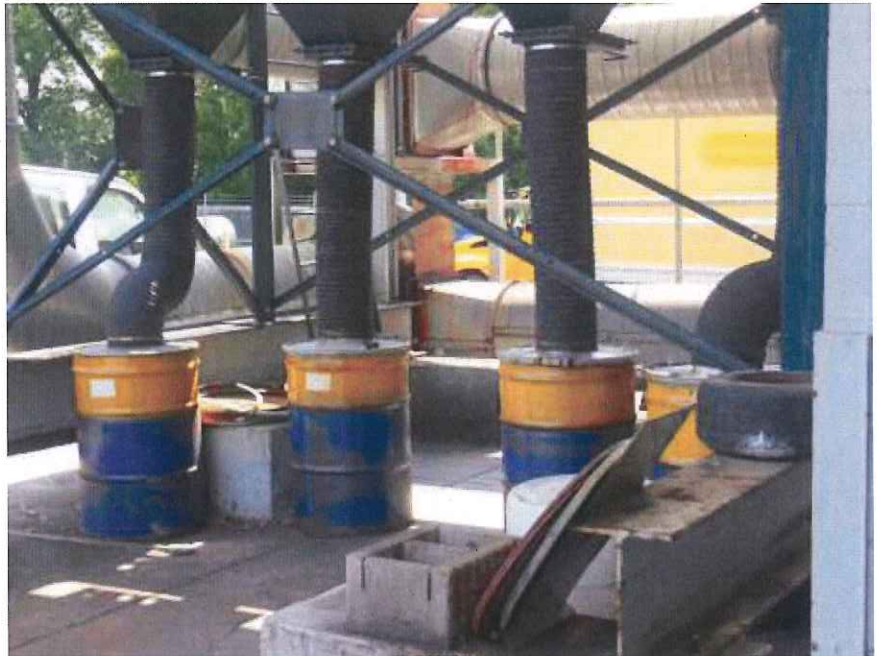
Baghouse dust was being collected in 55-gallon containers. When the containers are full, the dust is sent to Mexico for silver recovery.

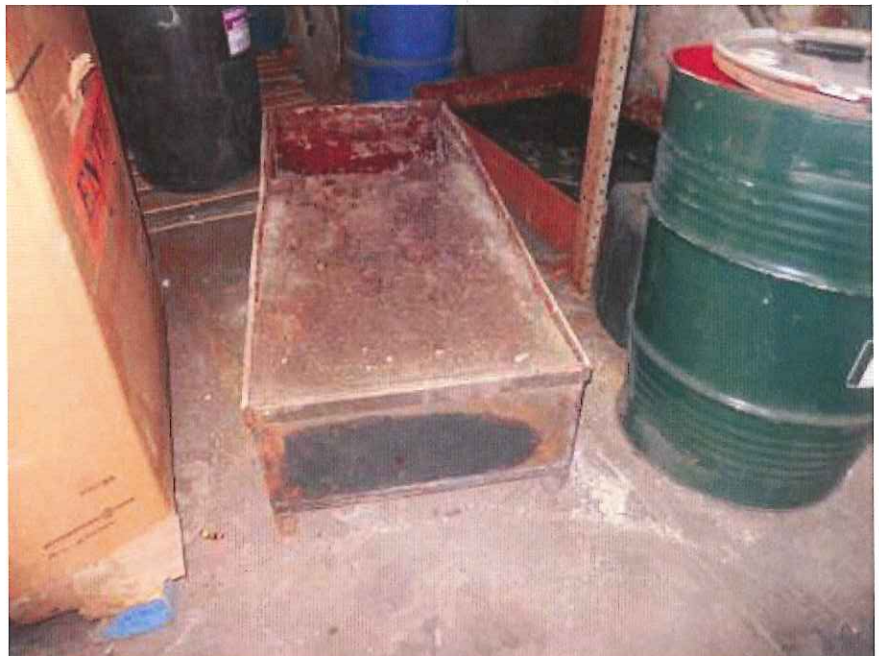
**Disk Number** 1  
**Photo Number** 14  
**Photo Filename** DSCN0686.JPG  
**Date/Time** 7/29/2014  
11:01:00 AM  
**Photographer** Jamie Paulin

Sludge was being collected after evaporation.

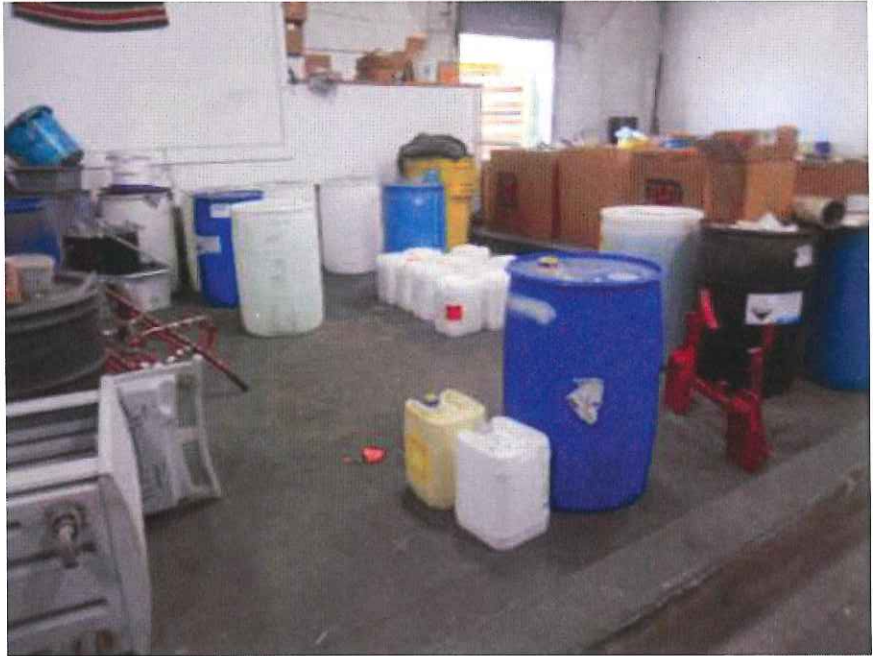
Enviro-Chem receives hazardous waste for precious metal recovery. They have a hazardous waste storage area for containers that are received. The wastes consisted of cyanide and silver waste. *See*, photograph 15.

Hazardous waste storage. In-coming hazardous waste was being stored here, such as cyanide waste and silver waste.

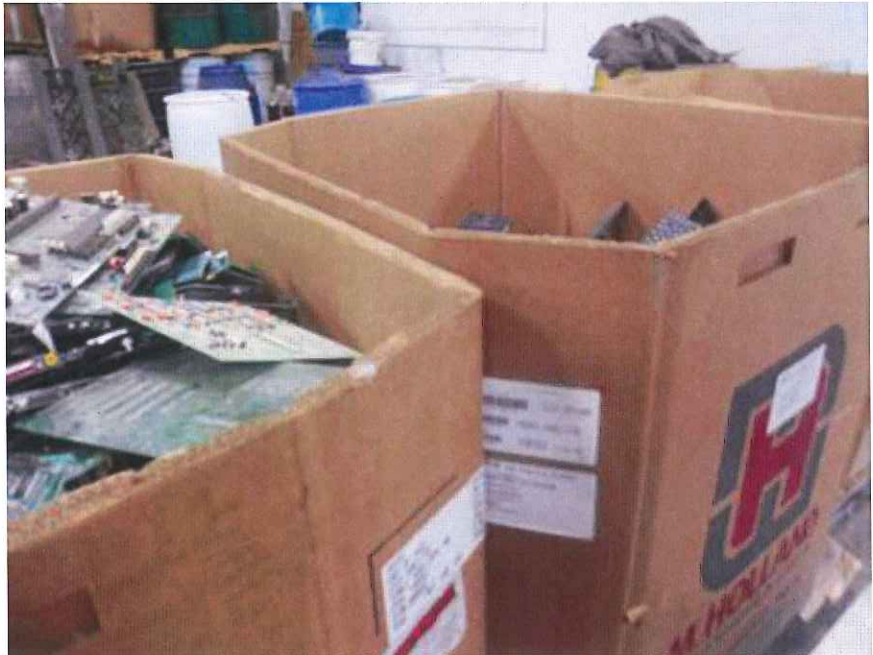
**Disk Number** 1  
**Photo Number** 16  
**Photo Filename** DSCN0688.JPG  
**Date/Time** 7/29/2014  
11:06:00 AM  
**Photographer** Jamie Paulin

Near the hazardous waste storage area, scrap circuit boards that have been received to be processed for precious metal recovery were being stored in open cardboard boxes. *See*, photograph 16.

Storage of scrap circuit boards that have been received to be processed for precious metal recovery.

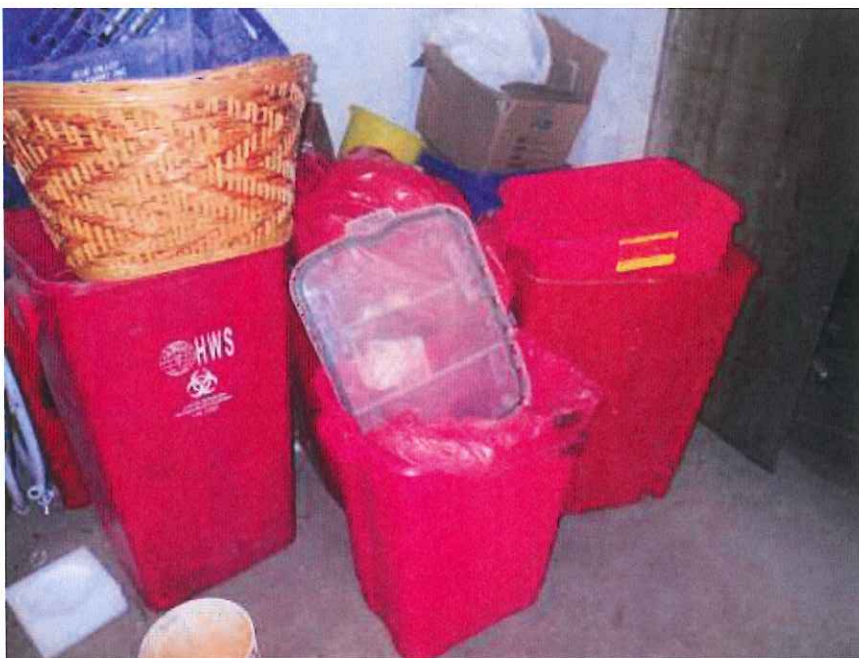
Dental amalgams were being stored prior to being shipped to Recycle Technologies for processing.

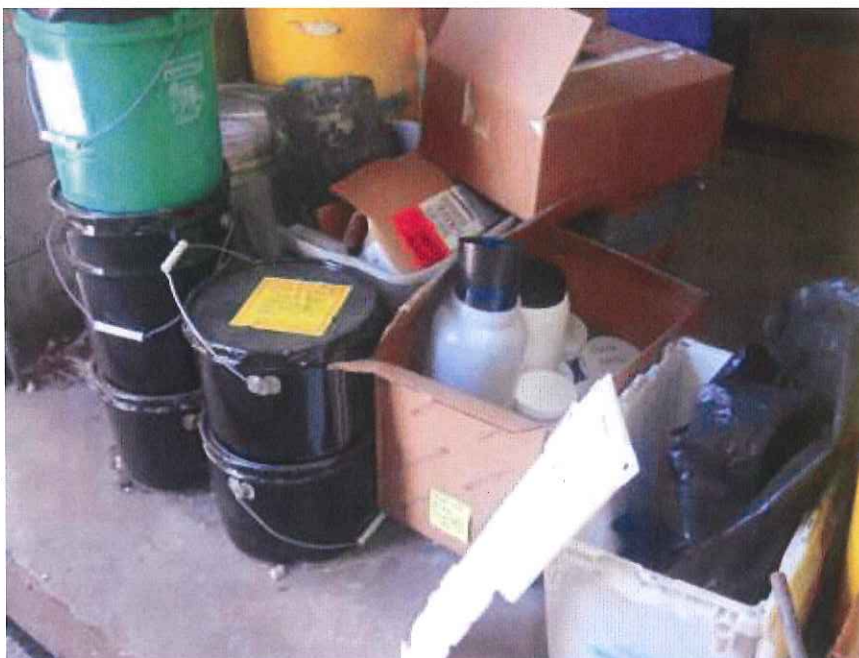
**Disk Number** 1  
**Photo Number** 18  
**Photo Filename** DSCN0690.JPG  
**Date/Time** 7/29/2014  
11:11:00 AM  
**Photographer** Jamie Paulin

Storage of material waiting to be processed.

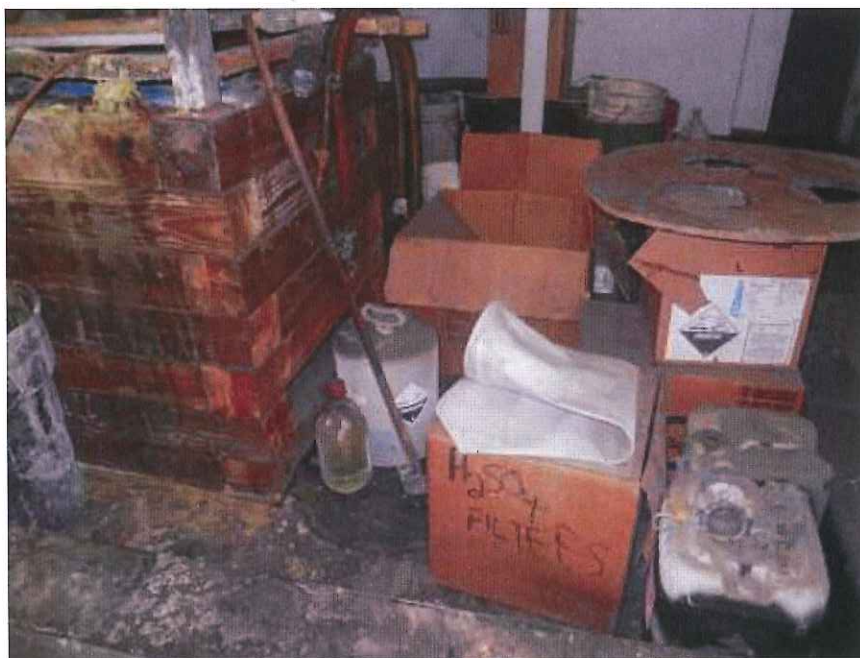
**Disk Number** 1  
**Photo Number** 20  
**Photo Filename** DSCN0692.JPG  
**Date/Time** 7/29/2014  
11:16:00 AM  
**Photographer** Jamie Paulin

At the time of the inspection, Enviro-Chem was storing various equipment, buckets and debris within the secondary containment of the hazardous waste acid storage tank.

Enviro-Chem also generates its own acid waste from the precious metals recovery process and it is stored in the Acid hazardous waste storage area in 55-gallon containers. Near this area, raw materials and equipment were also being stored on the floor. *See*, photographs 19 and 20.

Storage of raw materials and equipment.

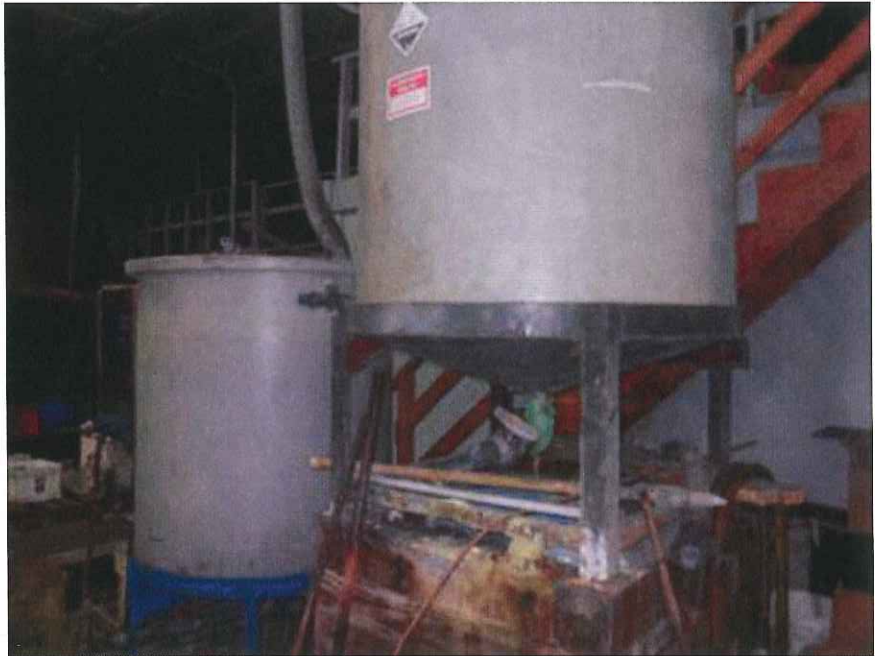
Mr. Perron showed us the precious metal recovery process. Two tanks were located in the area. One was labeled as hazardous waste. The hazardous waste tank was positioned on a stack of wooden planks. Mr. Perron explained the process to us as: 1) precipitation; 2) decanting off the liquid; 3) filter the liquid into the hazardous waste tank; 4) drain the liquid from the hazardous waste tank to the lower tank for neutralization; and, 5) drain the neutralized material into totes. The process was located in secondary containment; however there were several items, raw materials and equipment also being stored within this containment area. The floor appeared to be stained. *See*, photographs 21 and 22.

Hazardous waste storage tank. The tank was positioned on a stack of wooden planks. The tank was part of the chemical process used to recover precious metals.

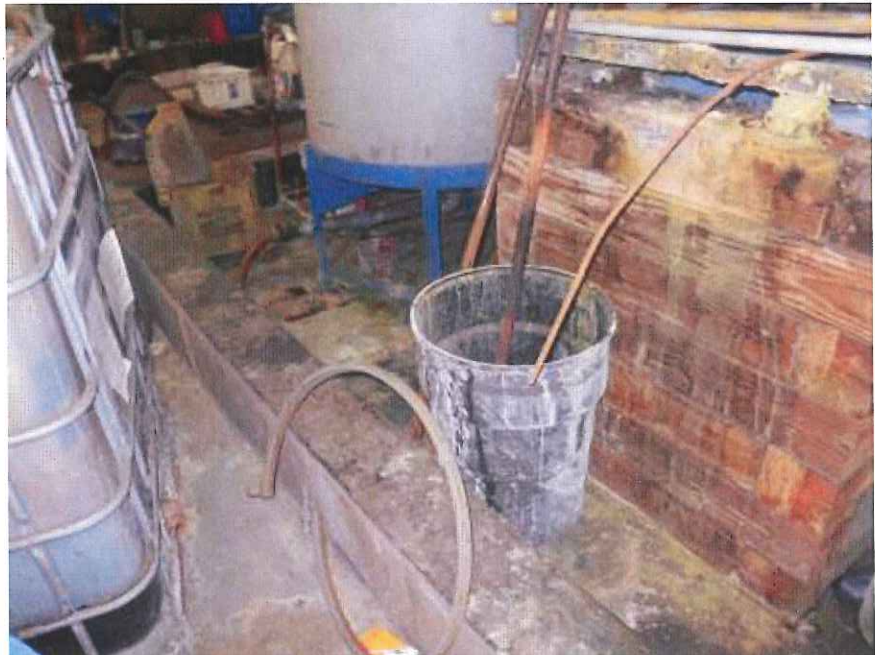
**Disk Number** 1  
**Photo Number** 22  
**Photo Filename** DSCN0694.JPG  
**Date/Time** 7/29/2014  
11:16:00 AM  
**Photographer** Jamie Paulin

Chemical Processing area. Hazardous waste tank storage and process tanks.

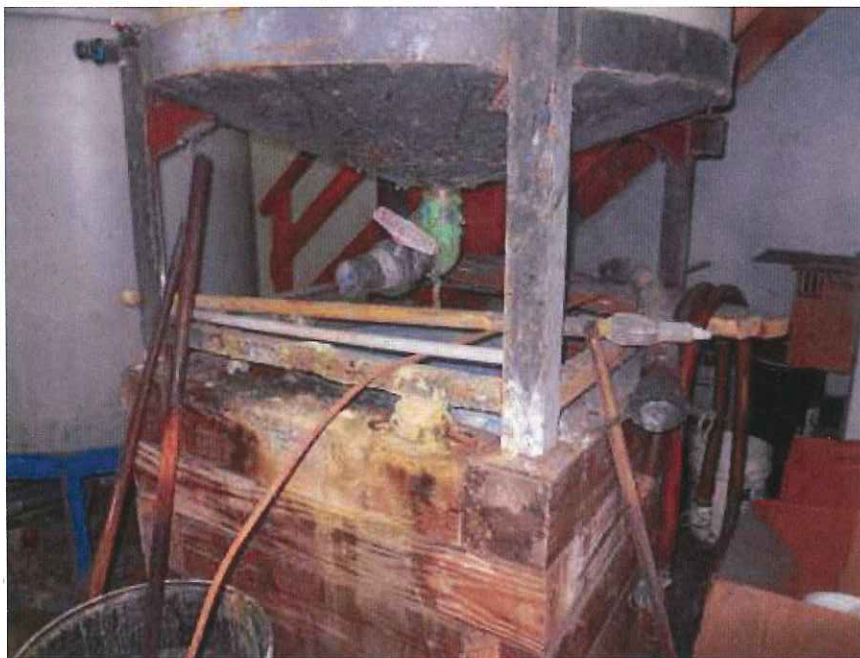
Once the acid material being stored in the tank, labeled as hazardous waste, can no longer be used in the process, Enviro-Chem empties the material into a tote that was being stored near the process area. The tote was labeled as a hazardous waste and it did have a start date of accumulation; however Mr. Perron was considering the tote to be an SAA container. I explained that if the hazardous waste level would go above 55 gallons, then they would need to put the container into their hazardous waste storage area within three days or consider this location to be a hazardous waste storage area. At the time of the inspection, it was difficult to decipher how many gallons were contained in the tote. *See*, photographs 23 and 24.

Bottom piping of hazardous waste storage tank. The pipe fixture is used to drain the tank when the material in the tank can no longer be used and is disposed of as a hazardous waste.

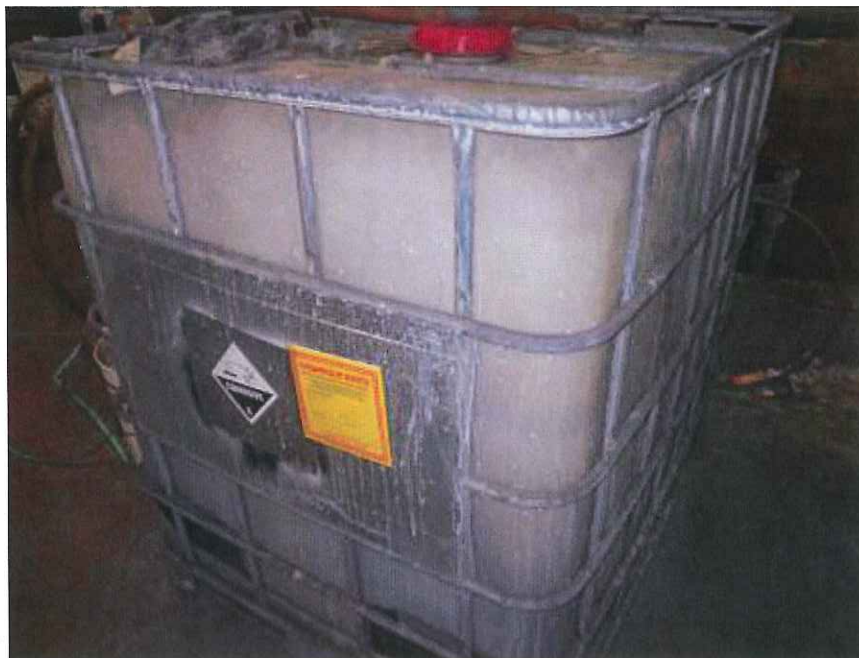
**Disk Number** 1  
**Photo Number** 24  
**Photo Filename** DSCN0696.JPG  
**Date/Time** 7/29/2014  
11:19:00 AM  
**Photographer** Jamie Paulin

At the time of the inspection, Enviro-Chem was storing more than 55 gallons of the hazardous waste acid in a cubic yard tote at a point of generation.

Hazardous waste storage. The tank is emptied into a tote, which was being stored near the process area.

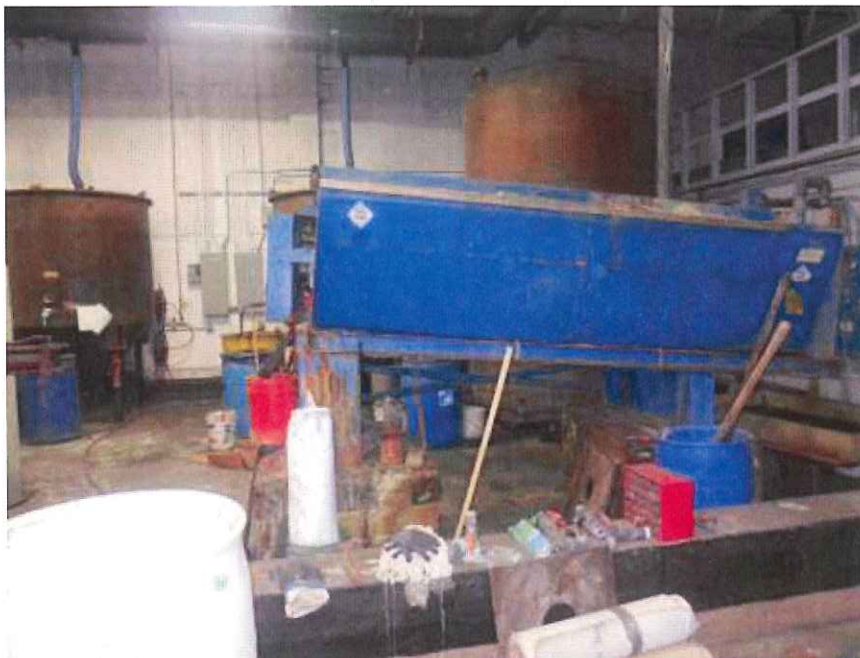
Evaporator. The evaporator is used to reduce the liquid waste after it goes through waste water treatment.

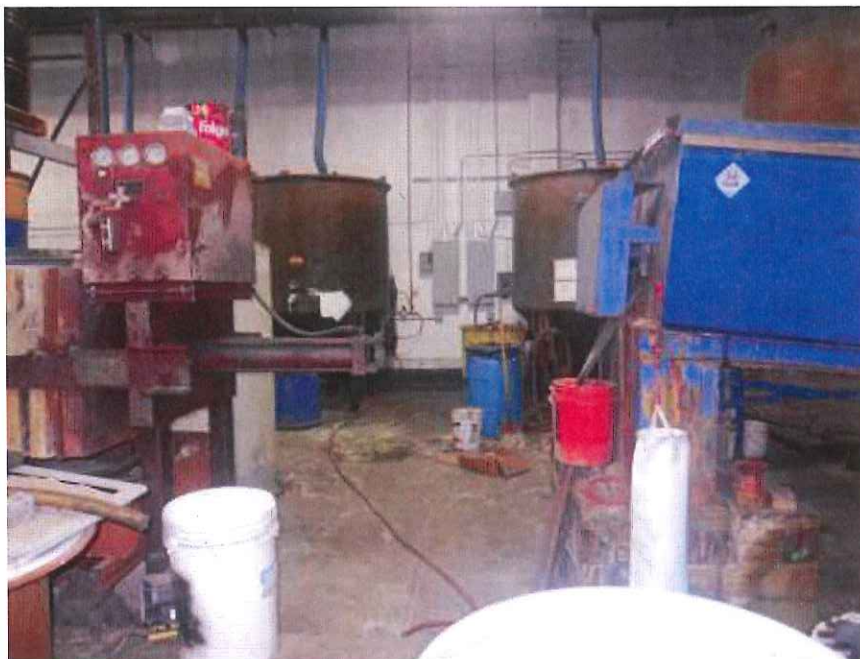
**Disk Number** 1  
**Photo Number** 26  
**Photo Filename** DSCN0698.JPG  
**Date/Time** 7/29/2014  
11:22:00 AM  
**Photographer** Jamie Paulin

Evaporator. Hazardous waste storage tanks were located in the back area. The waste is stored in the tanks prior to the evaporator.

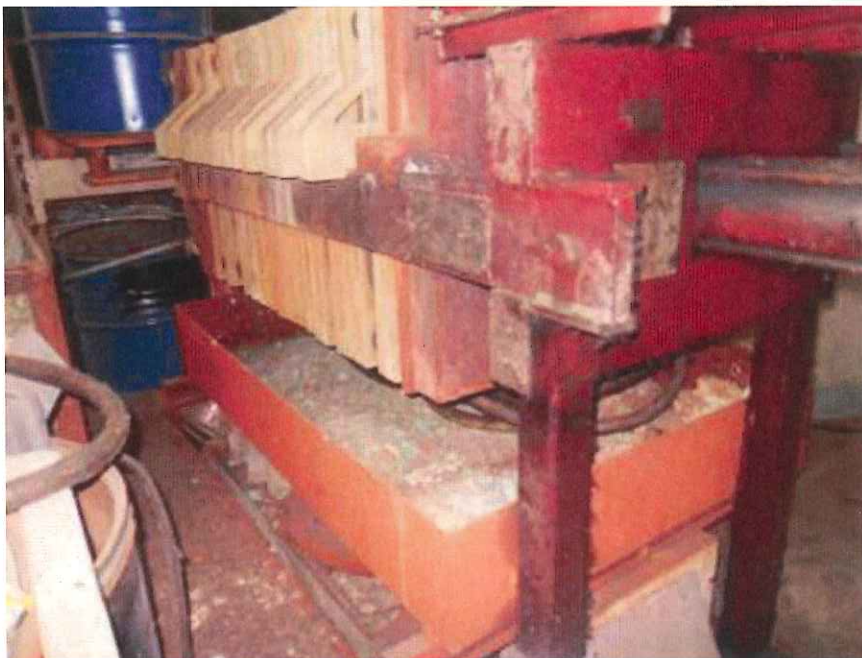
Filter press that is no longer used and has not been used in 10 years. The press was still storing material that had not been cleaned out in 10 years.

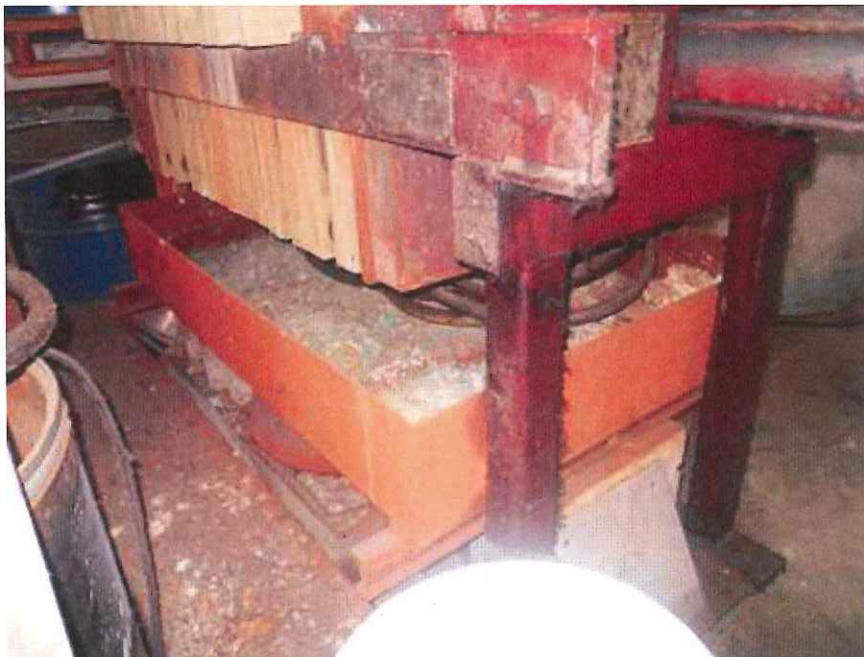
**Disk Number** 1  
**Photo Number** 28  
**Photo Filename** DSCN0700.JPG  
**Date/Time** 7/29/2014  
11:23:00 AM  
**Photographer** Jamie Paulin

Liquid that is decanted off of the evaporator once was routed through this filter press. This press has not been used in several years and the filter cake is still being stored inside.

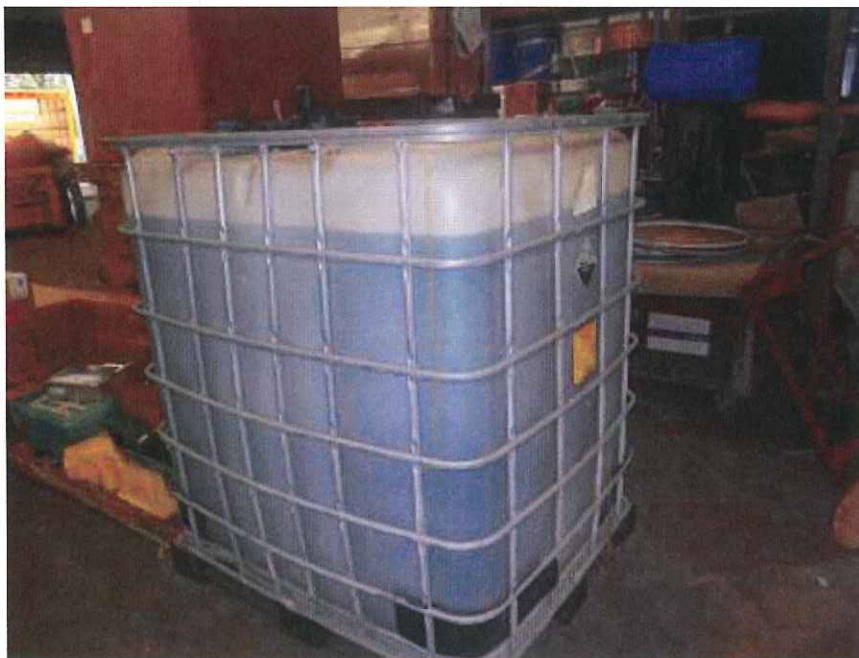
Hazardous waste storage. A tote of hazardous waste, that was received, was being stored prior to precious metal recovery.

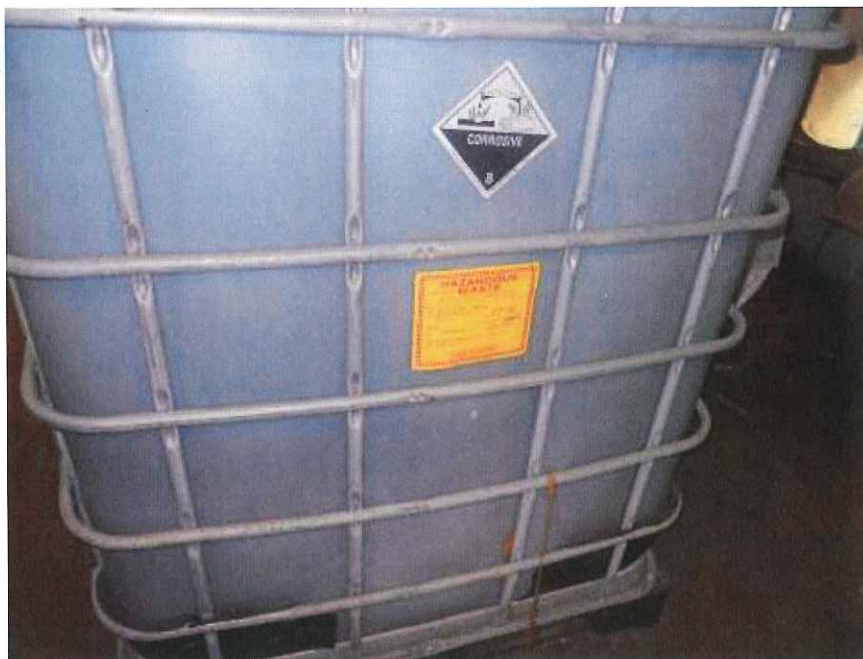
Hazardous waste storage. A tote of hazardous waste, that was received, was being stored prior to precious metal recovery.

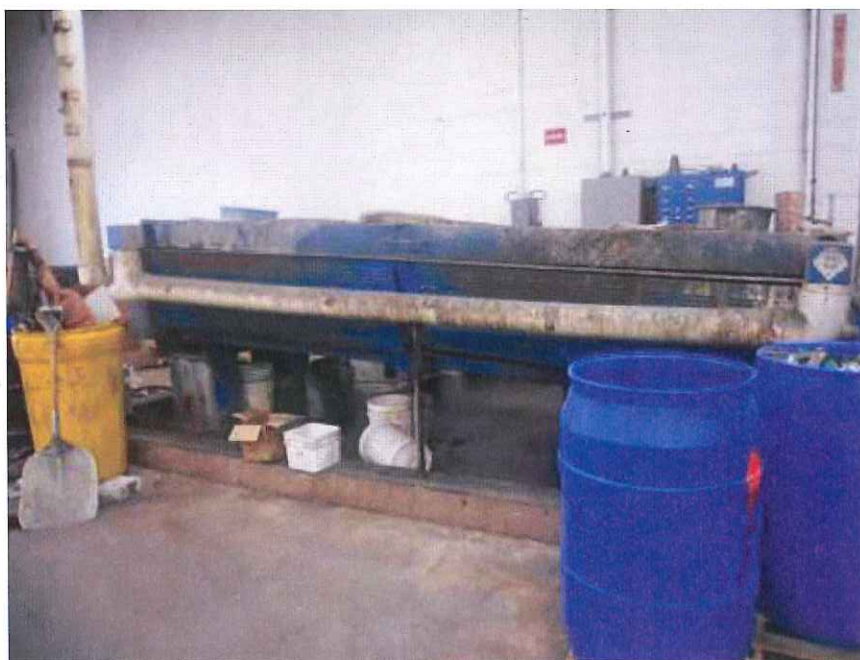
At the time of the inspection, Enviro-Chem had not made a determination whether the thick slurry waste, located underneath the evaporator that was still in-use, was hazardous.

Evaporator. A thick slurry was located underneath within the secondary containment.

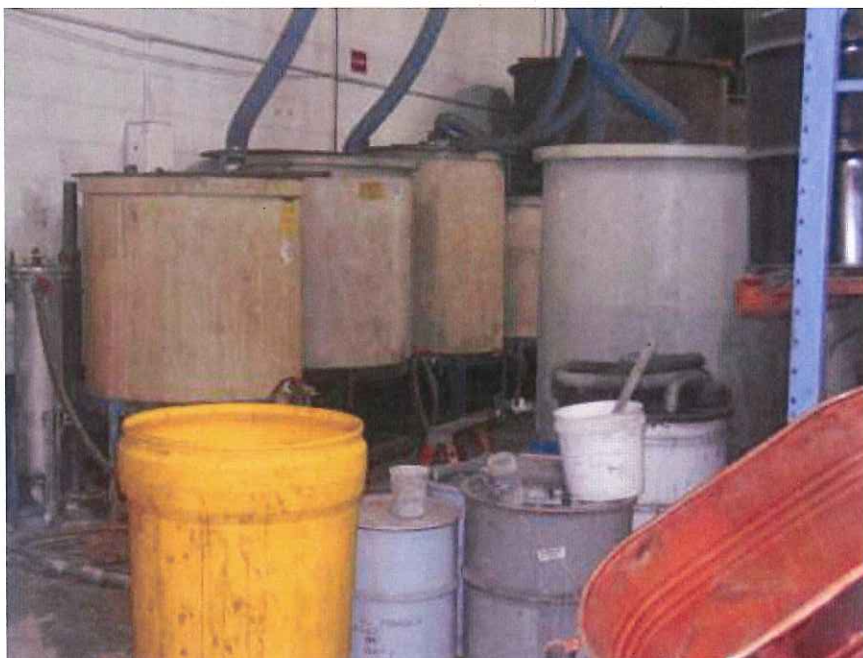
Cyanide treatment process prior to evaporator.

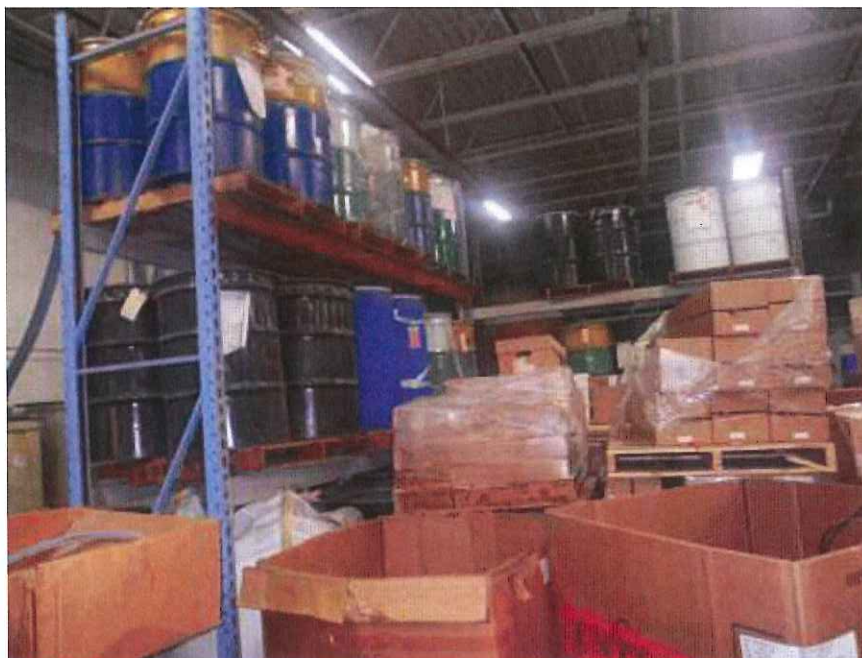
**Disk Number** 1  
**Photo Number** 34  
**Photo Filename** DSCN0706.JPG  
**Date/Time** 7/29/2014  
11:33:00 AM  
**Photographer** Jamie Paulin

Received material awaiting processing was being stored on the shelves.

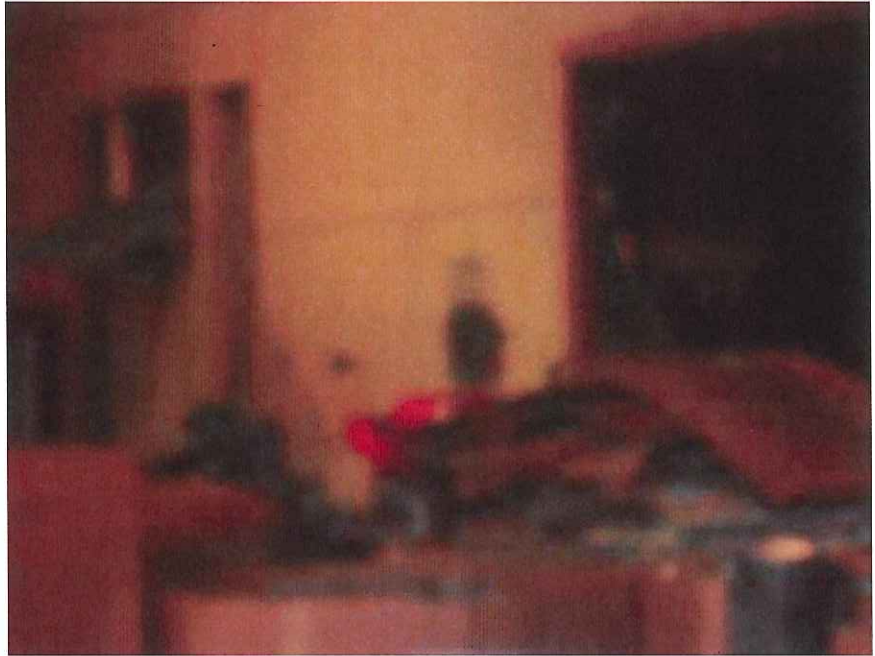
Enviro-Chem's non-ferrous facility, located at 20005 Co Rd 81. Here they store all non-ferrous metal items awaiting precious metal processing at the main facility.

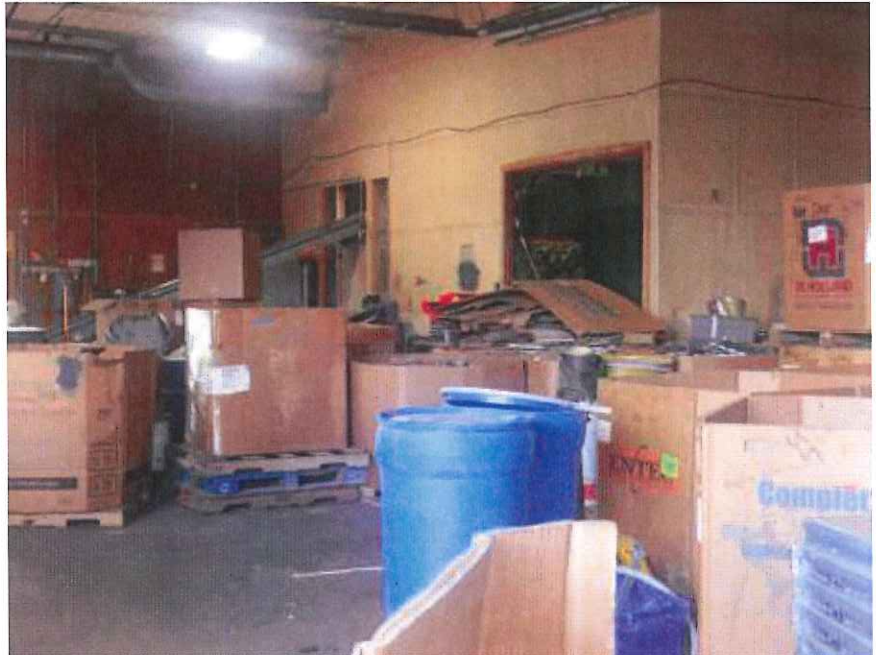
**Disk Number** 1  
**Photo Number** 38  
**Photo Filename** DSCN0710.JPG  
**Date/Time** 7/29/2014  
2:35:00 PM  
**Photographer** Jamie Paulin

A shredder was located at the non-ferrous storage facility. The shredder is used to shred all metal items prior to precious metal processing.

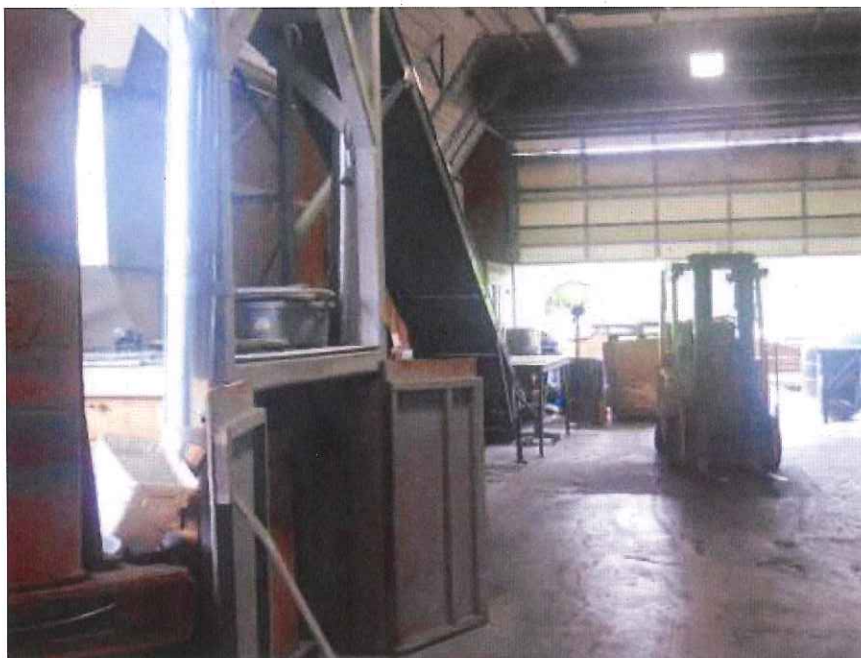
A shredder was located at the non-ferrous storage facility. The shredder is used to shred all metal items prior to precious metal processing.

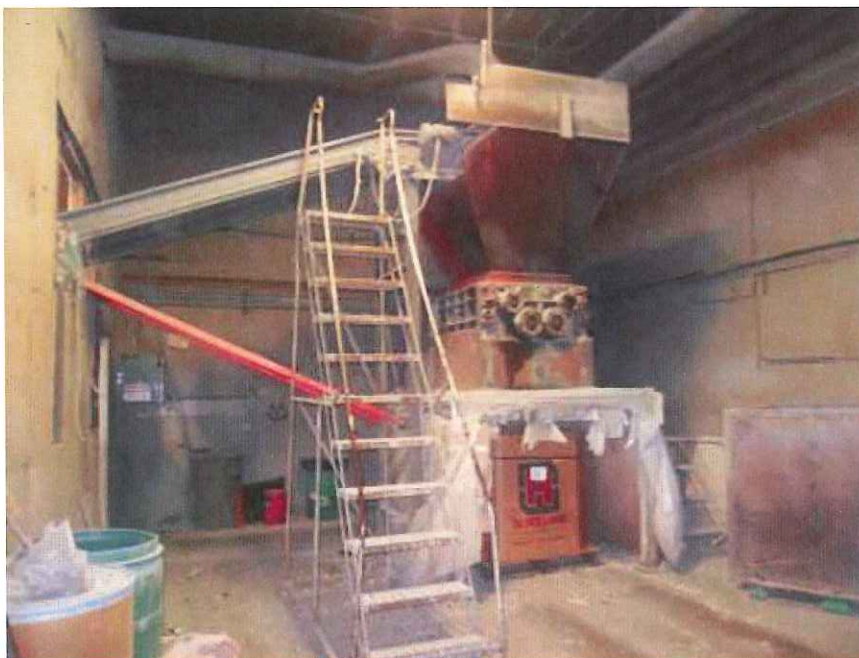
**Disk Number** 1  
**Photo Number** 40  
**Photo Filename** DSCN0712.JPG  
**Date/Time** 7/29/2014  
2:39:00 PM  
**Photographer** Jamie Paulin

A shredder was located at the non-ferrous storage facility. The shredder is used to shred all metal items prior to precious metal processing.

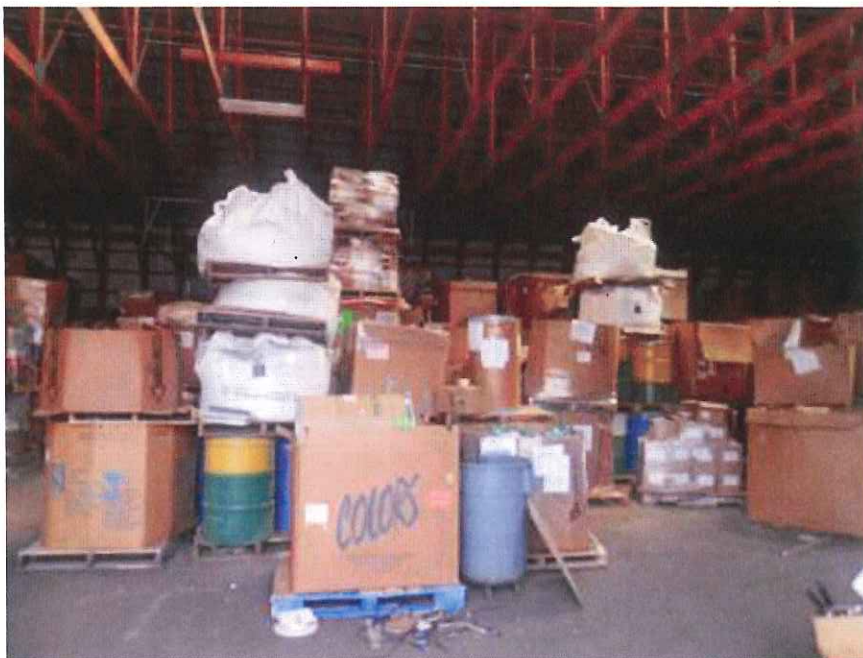
Storage of metal items, inside the building, that have been received. The items are stored here prior to shredding and shipping to the main facility for precious metal recovery.

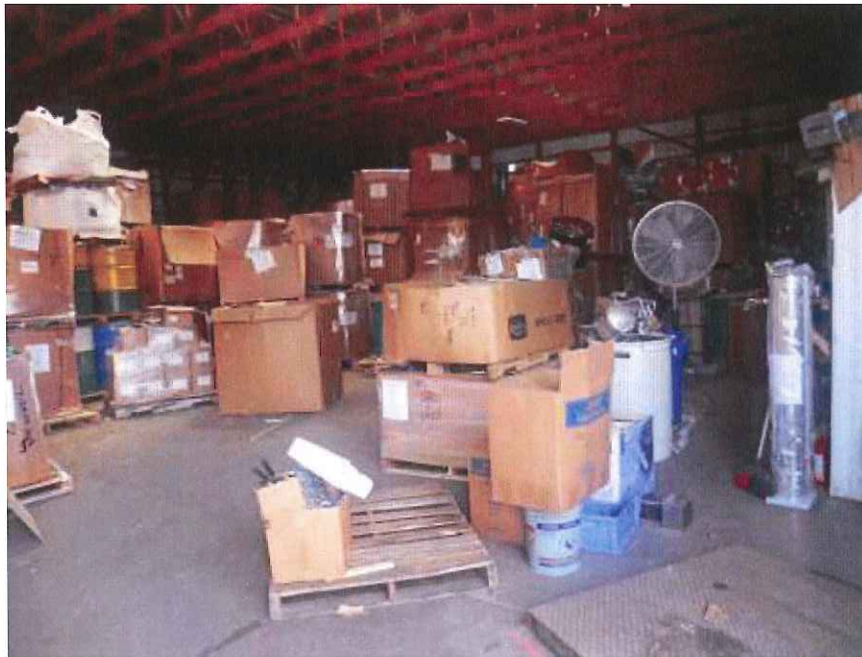
**Disk Number** 1  
**Photo Number** 42  
**Photo Filename** DSCN0714.JPG  
**Date/Time** 7/29/2014  
2:45:00 PM  
**Photographer** Jamie Paulin

Storage of metal items, inside the building, that have been received. The items are stored here prior to shredding and shipping to the main facility for precious metal recovery.
